CONNECTICUT RIVER BASIN
WINCHESTER, CONNECTICUT

CRYSTAL LAKE DAM CT 00104

PHASE I INSPECTION REPORT NATIONAL DAM INSPECTION PROGRAM

AUGUST, 1979

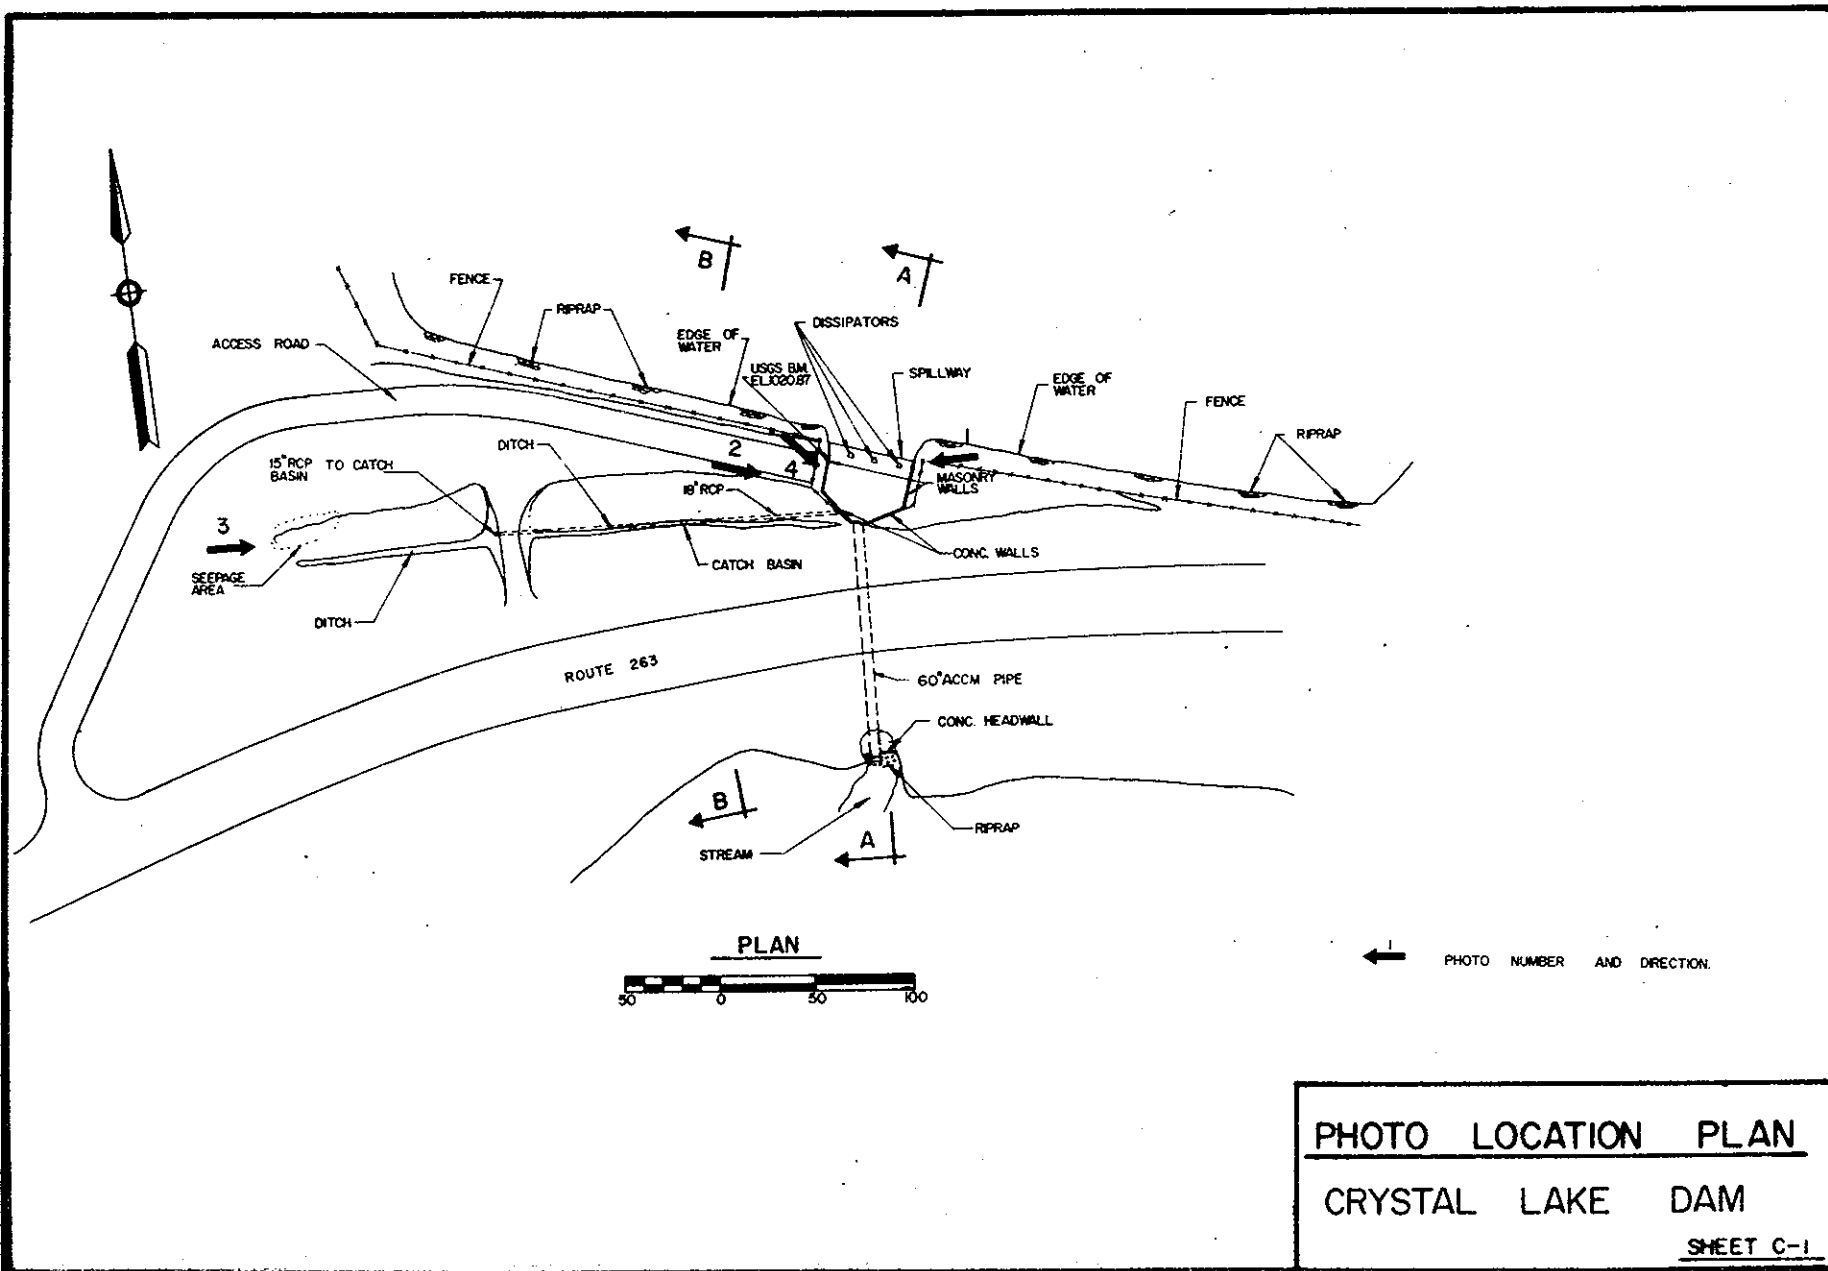
Crest - The crest of the dam has a grass cover (Photos 1, 2, and 3). No misalignments, cracks or depressions were observed. Several large trees were noted on the crest of the embankment to the left of the spillway.

Upstream Slope - The slope protection is riprap and a grass cover at the crest. No erosion or sloughing was observed, however trees of 4 to 6 inches in diameter were noted (Photo 1).

Photo 1 - Crest of embankment and spillway from left spillway training wall. Note trees on upstream slope of embankment and deterioration of upper right training wall (May 1979)
